## Divator breathing valve

This safety advice applies to all Divator breathing valves with serial number 1631001 to 2107999 and spare part kits containing valve inserts with manufacturing date August 1st, 2016 to February 9th, 2021. Older breathing valves may also be affected by this bulletin if they have undergone service and had valve inserts fitted that were manufactured during this period.

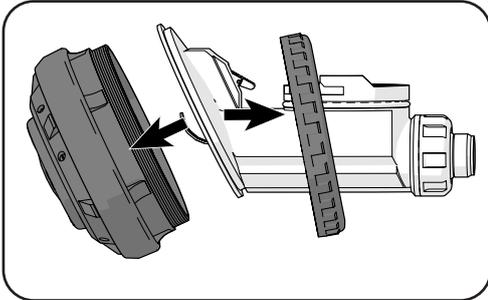
### 1. Remove the exhalation unit.

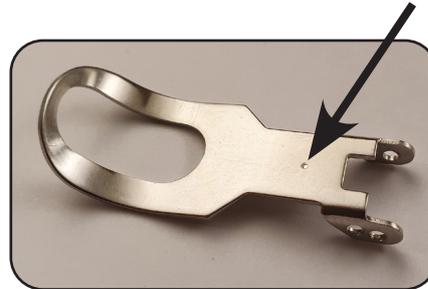
2. Check if the lever has a punched dot on it. If it has a dot, it is the new version and there are no need to check the lever height or inspect the surfaces of the lever support.

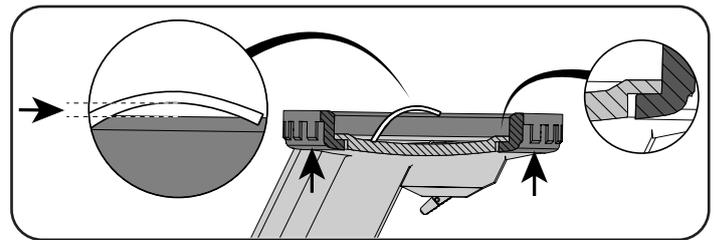
3. Check the lever height. If it is too low, replacement must be done before the next use, as this may be a sign of wear without visible damage.

*With lever bar:* The lever should be in the upper part of the cut-out.

*Without lever bar:* Remove the exhalation unit except the locking ring. Push the locking ring upwards so that it lies against the edge. Check that you can see a gap between the lever and the upper edge of the locking ring. This test method is only for checking if the lever is too low and has no upper limit.

Important! Hold the breathing valve upwards as shown in the image.

**Important!** It is not permitted to manually bend the lever to make a gap.

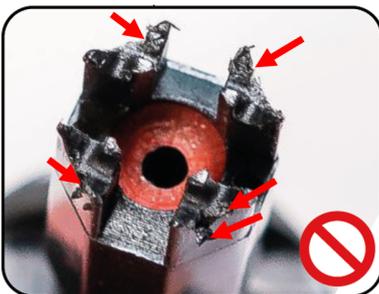
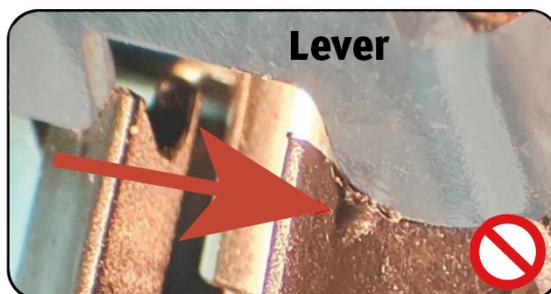
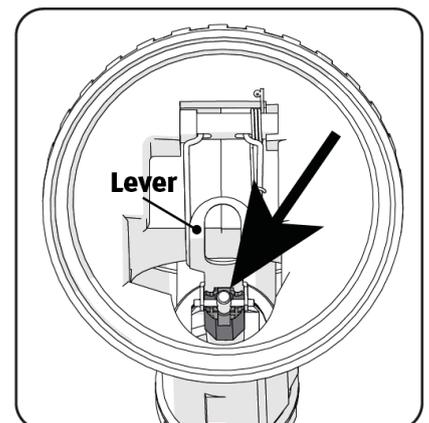
### 4. Check the contact surfaces on the lever support.

Check that the contact surfaces and the outside surface of the lever support is undamaged. If it is damaged like indicated by the red arrows in the images, the parts must be replaced before next use.

There could be exceptional circumstances where the air delivery through the unit could be restricted or even potentially ceased due to mechanical damage on the lever support. Such damage can occur if the lever height is adjusted incorrectly or if the lever on a removed valve insert is handled in such a manner that it is angled over by more than 50 degrees. Damage can also occur during normal use by wear.

By replacing the lever with a new version the risk of this failure mode is eliminated. The lever support with sealing diaphragm must be replaced at the same time. The replacement procedure is required to be performed by a certified service technician according to the instructions detailed within this bulletin.

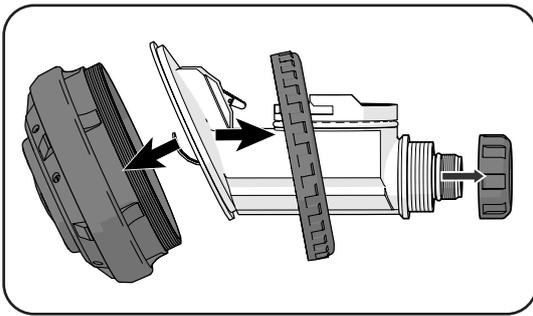
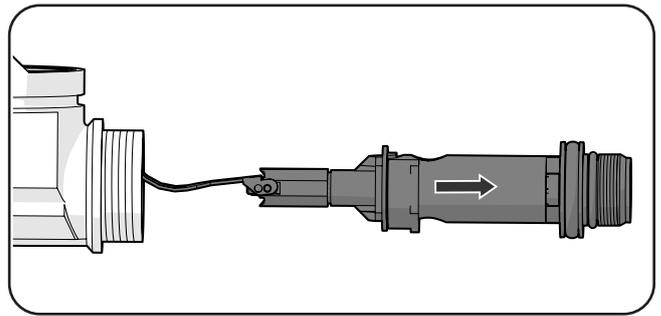
1. Remove the exhalation unit and the nut.
2. Pull out the valve insert.

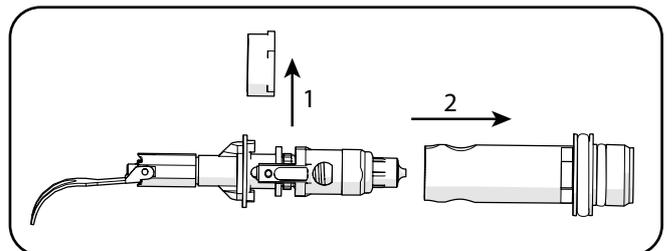
3. Remove the retaining ring and then pull out the valve insert from the connection nipple.

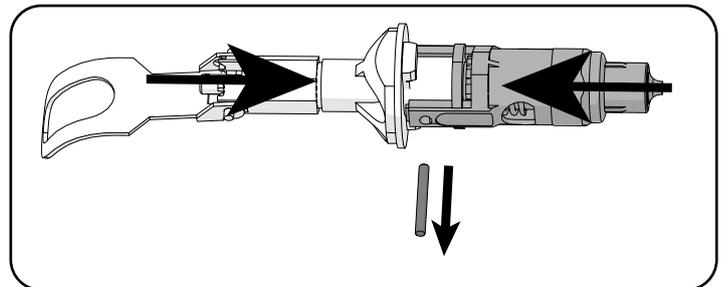
4. Press together the valve insert by hand so that the pin can fall out.

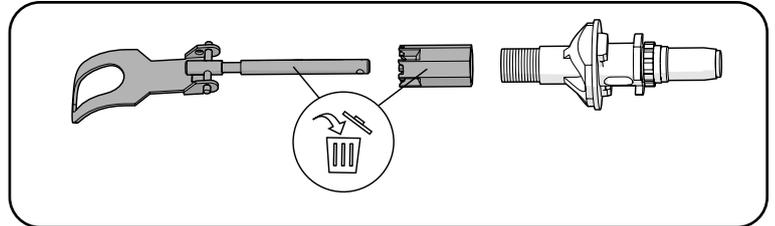
6. Remove the lever support and discard the lever and the lever support.

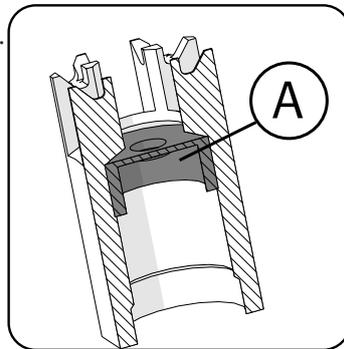
7. Check that the sealing membrane (A) is located in the lever support.

8. Carefully tighten the lever support by hand. Then turn it counter-clockwise a few turns to get about 0.7 mm spacing.

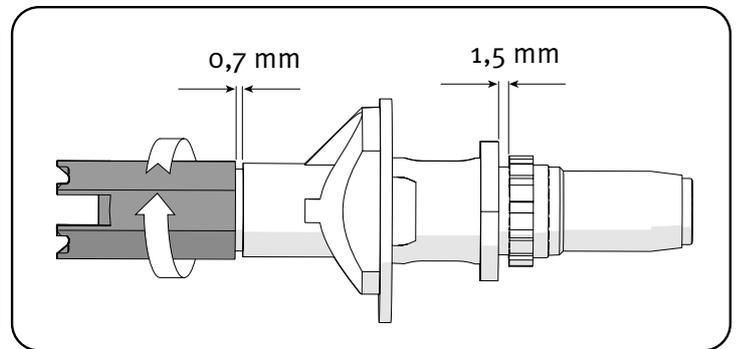
9. Adjust the adjusting nut to get about 1.5 mm spacing.

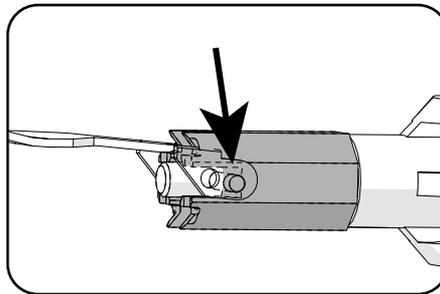
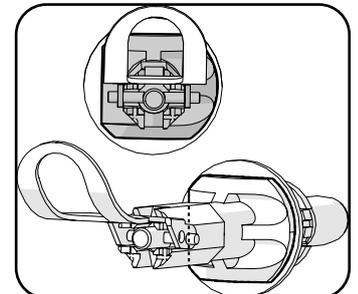
10. Mount the lever in the lever support with the pin in one of the deep slots. Check that the bend ends up in the right direction according to the rounded side of the valve insert.

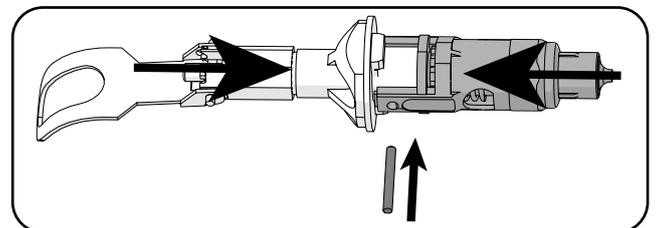
11. Assemble the valve insert with the new lever and lever support. Press the valve insert together and put the pin back.

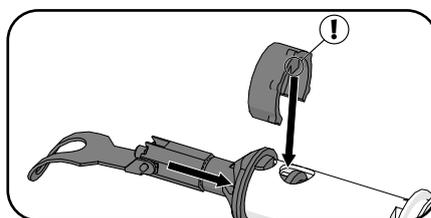
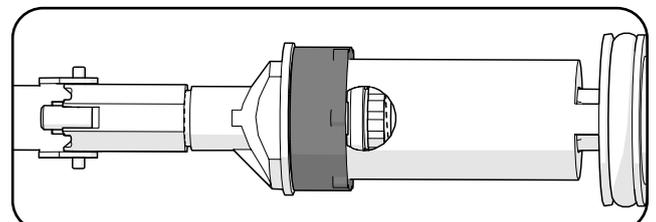
12. Assemble the valve insert sub assembly in the connection nipple and lock it with the retaining ring. Make sure to fit the retaining ring correctly.

The valve insert sub assembly and the connection nipple should not be able to be pulled apart.

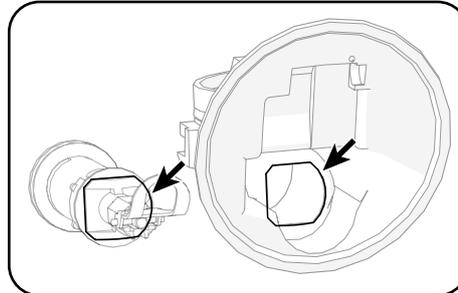
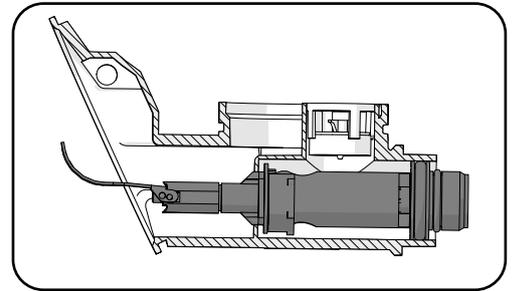
13. Insert the valve insert assembly in the breathing valve. Make sure to insert it in the correct position.

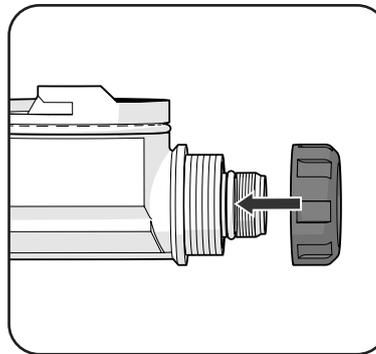
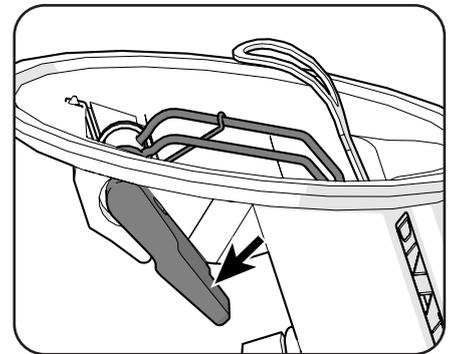
14. Assemble the nut by hand.  
15. If the breathing valve is of safety pressure type. Make sure that the handle is in the position shown in image.

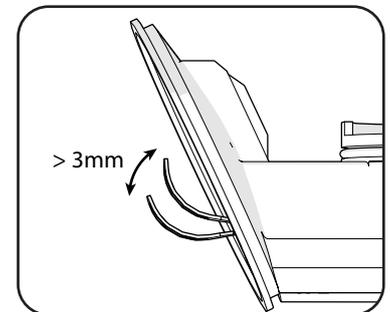
16. Make sure that the lever has a resistless movement of at least 3 mm.

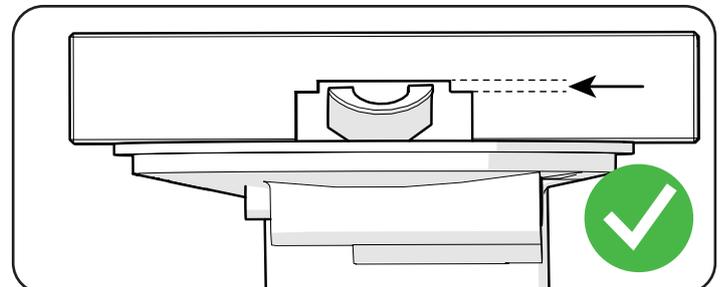
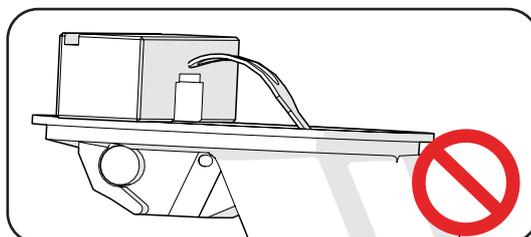
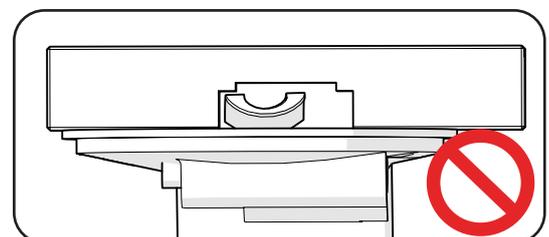
17. Use the lever bar to make sure that the lever is in the correct height. The lever must be in the upper area of the lever bar.

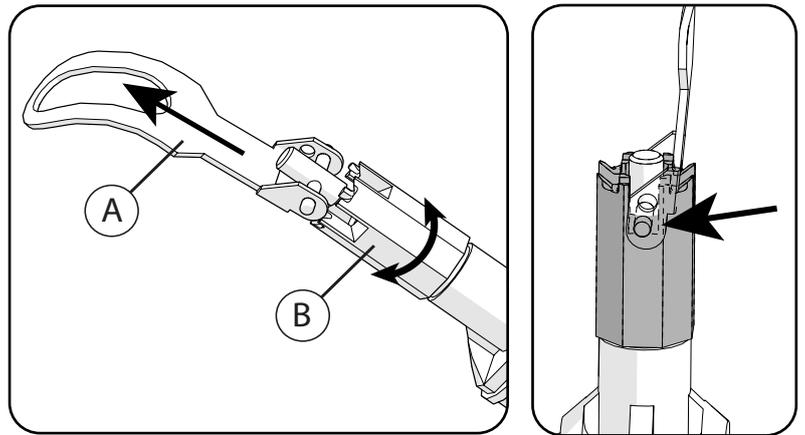
18. If height adjustment of the lever is necessary:
  - a, Disassemble the valve insert from the breathing valve.
  - b, Pull out the lever (A) and turn the lever support (B) 1 step to make it higher or lower.
  - c, One quarter turn results in a height difference of 1,25 mm on the lever.
  - d, Make sure to put the lever in one of the deeper grooves in the lever support as seen on image.
  - e, If two settings is possible within the limits, use the highest setting.
  - f, Reassemble the valve insert into the breathing valve and check the lever according to step 16 and 17 again.

**IMPORTANT!** When adjusting the height of the lever, it is very important that part A is lifted high enough so that part B does not touch part A when adjusting. When part A is released, it is very important that it slides directly into the correct position. If it is placed incorrectly, it can damage the lever support.

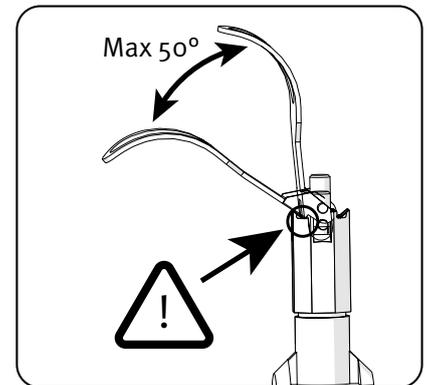
**IMPORTANT!** Never angle the lever more than 50 degrees as this may damage the contact surfaces on the lever support. When the valve insert is mounted in the breathing valve housing, the lever is prevented from angling more than 50 degrees. When the valve insert is removed from the breathing valve housing, the lever can be angled more than 50 degrees and thus damage the lever support.

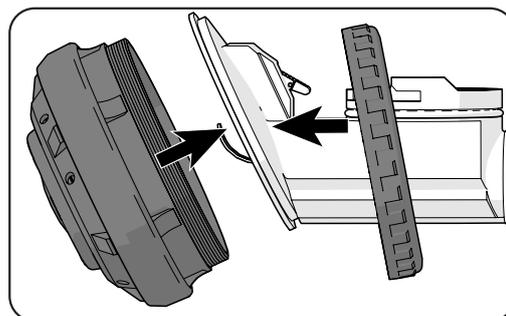
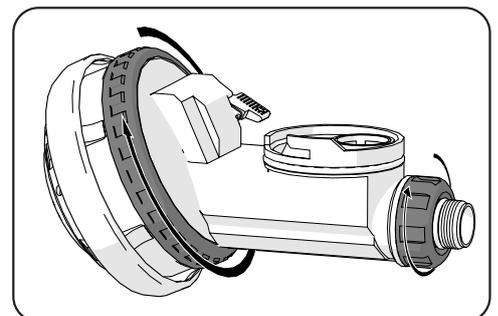
19. Reassemble the exhalation unit and the nut.
